“NO BUILD” ANALYSIS CODE DEFICIENCIES & DEFERRED MAINTENANCE EVALUATION

NORTH READING MIDDLE AND HIGH SCHOOLS
NORTH READING, MASSACHUSETTS

DECEMBER 23, 2011

DORE & WHITTIER
ARCHITECTS, INC.

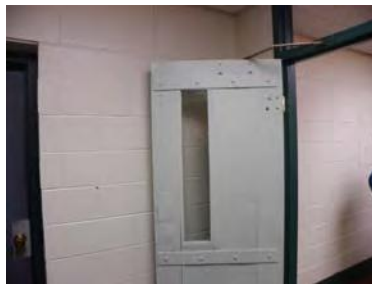
Doors in need of repair

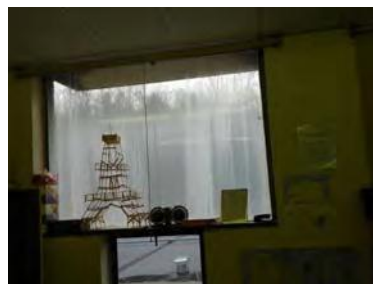
Aged glazing

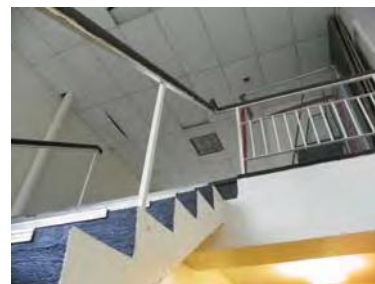
A major safety factor noted in both the Middle and High School buildings is the lack of code compliant handrails and guard rails at stairways. The code requires that guard rails are a minimum height of 42” above the finished floor and that they are constructed in such a way that a four inch spear cannot pass through the openings between balusters. Additionally there are rudiments for the size, location, and extension of handrails that have not been met at the existing stair locations in each of the schools. We recommend the replacement of the guardrails and handrails in all locations.

Missing guardrails

1.20	Replace handrails and guard rails at all stairs to meet code	Coordinate work with 1.01
1.21	Install no skid carpet or tile in auditorium sloped isles

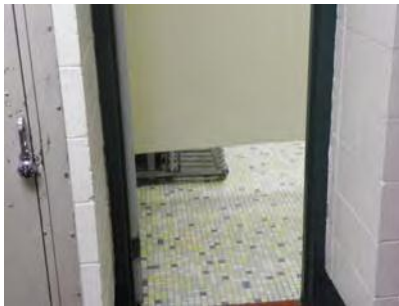
Non-accessible doorway

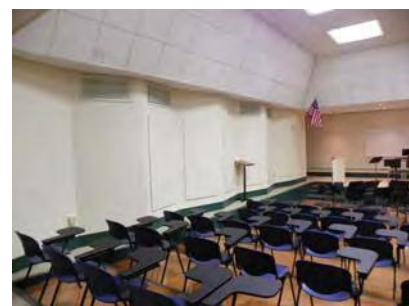
Non-accessible music classroom

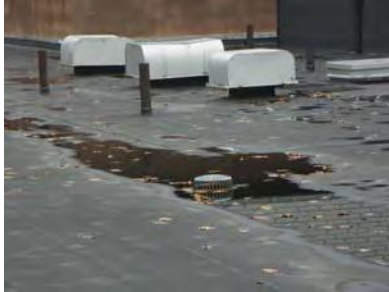
Ponding at roof drain

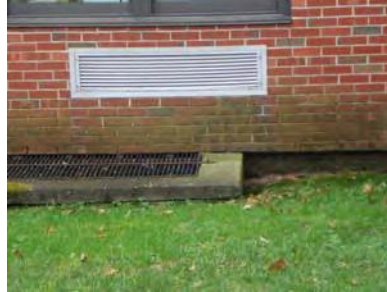
Mold on exterior wall

5.01	Clean and re-surface existing exterior brick walls with mold resistant application	
	5.02	Replace exterior doors and frames that are rusting	Coordinate work with 1.02

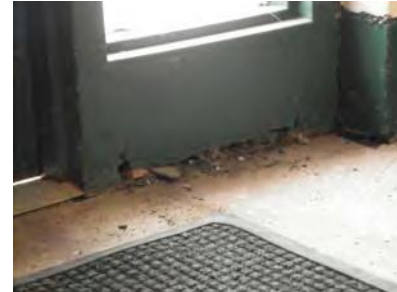
Rusting door frame

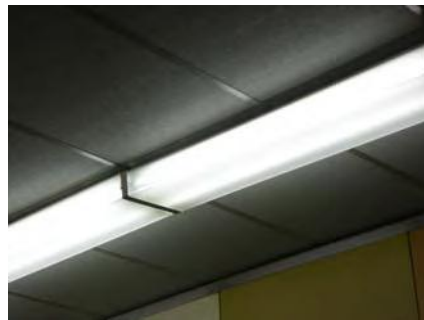
Existing lighting

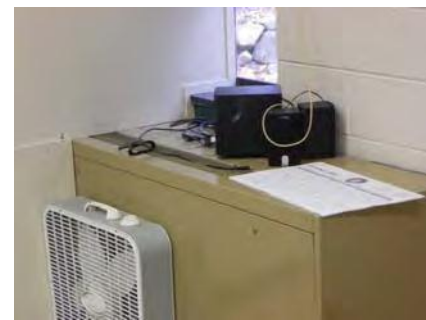
Existing HVAC units

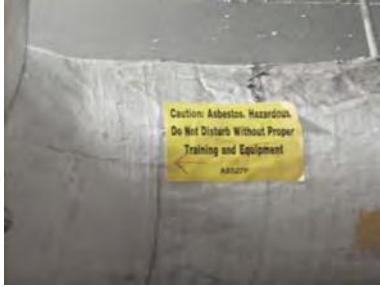
Asbestos insulation

1.12	Remove pipe insulation containing asbestos and replace with new insulation (typical through out building)	Coordinate work with 7.02
	1.13	Disconnect acid waste system from the sanitary system, install holding tanks outside and discharge acid waste to exterior tanks	Coordinate work with other work in the science labs -1.09, 1.15, 1.16, 1.17

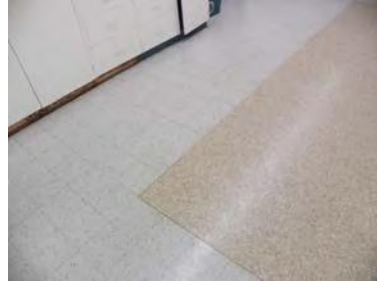
Existing VAT and new floor tiles

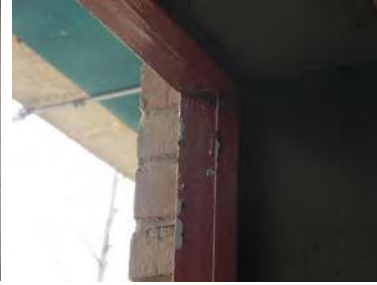
Existing windows
